TOWN PLANNING REPORT

Wangaratta North West Growth Area Precinct 1A Development Plan

Worland & Lindner Roads Wangaratta

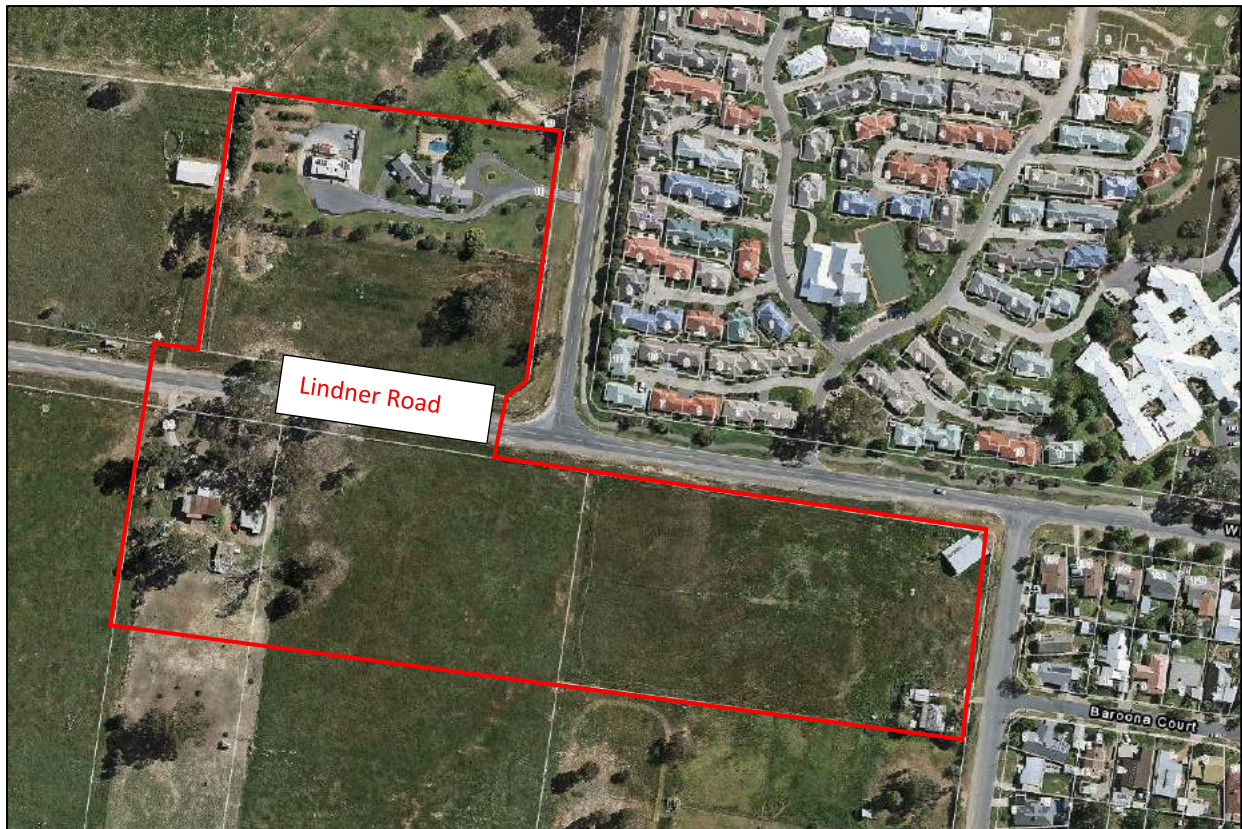
Figure 1: Precinct 1A shown in red outline (Source: RCOW online mapping)

Approval of the submitted Precinct 1A Development Plan is sought from Rural City of Wangaratta Council (RCOW) under Clause 43.04-3 of the Development Plan Overlay for land described as Lot 2 PS333975, Lot 4 and (part) Lots 1, 2 and 3 LP41832 (refer to Figure 1 below).

The subject land is contained within five separate titles shared between four different owners. Refer to the cadastral boundaries shown in white in Figure 1. Once a Precinct Development Plan has been approved for Precinct 1A, separate applications will be made to RCOW to subdivide the land in accordance with the approved Development Plan. This will be in the form of planning permit applications for the staged development of the Precinct and may include additional permit triggers such as the removal of native vegetation and commercial use and development.

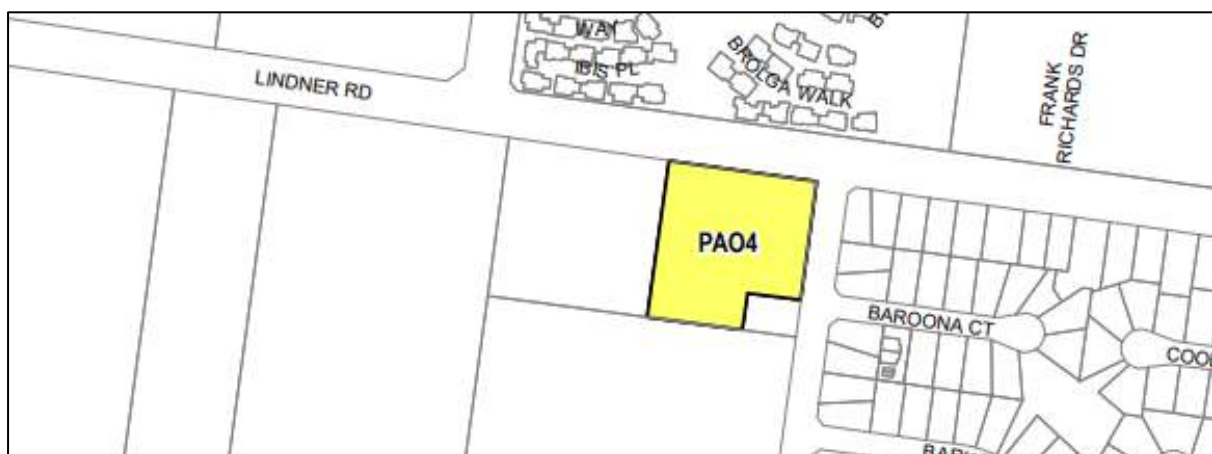
Figure 8: Public Acquisition Overlay map (Source: DELWP online mapping)

The eastern half of Property 19 is affected by the Public Acquisition Overlay – Schedule 4. Refer to **Figure 8** below. The POA4 is applied to the land so that RCOW can purchase the land for a public open space area and, in doing so, create a gateway into the North West Growth Area. Schedule 4 to the PAO identifies the purpose of acquisition as *'drainage and open space'*.

The POA4 is not applied to the existing dwelling in the south-eastern corner of the site. The intention is to subdivide this dwelling from the balance of the public park so that the current owners can realise the value of the dwelling and retain it in the new Precinct.

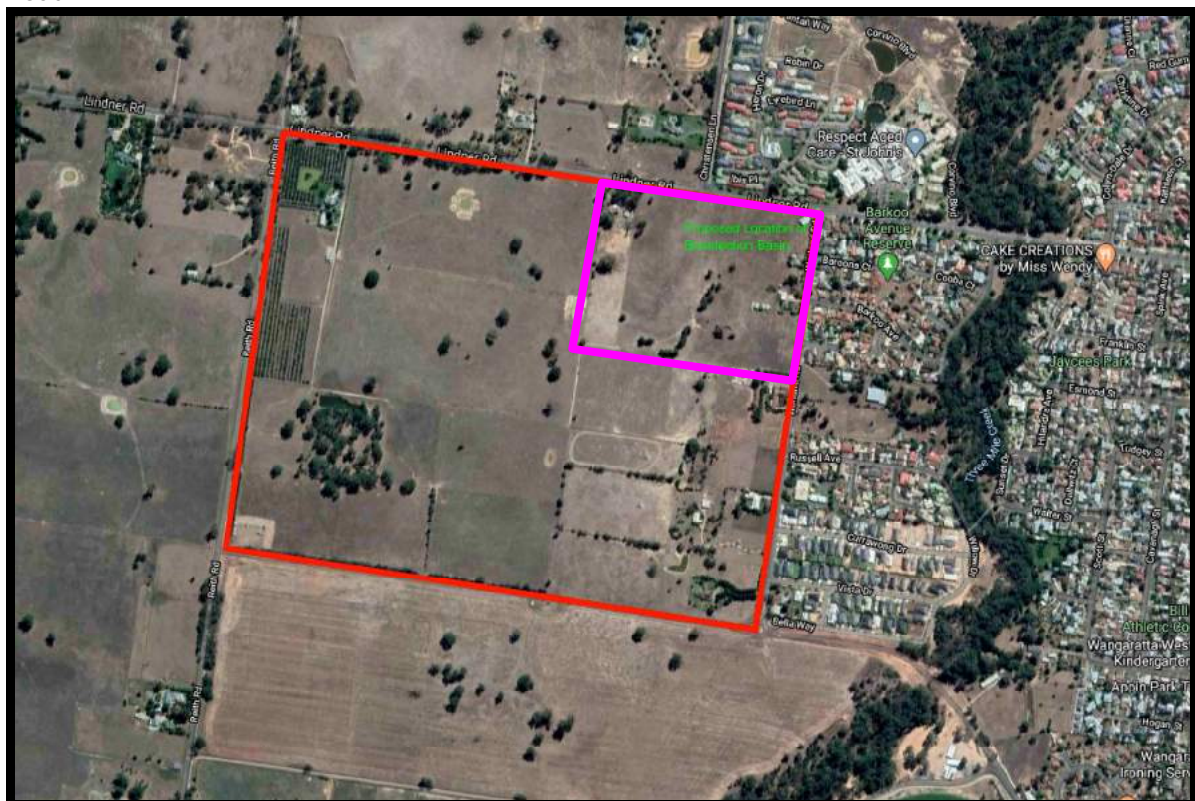
Figure 3-1– Aerial Image – Catchment 4N

Refer to Figure 3.1 below for an aerial view of the 4N Catchment and the SMC at 2 – 8 Worland Road.

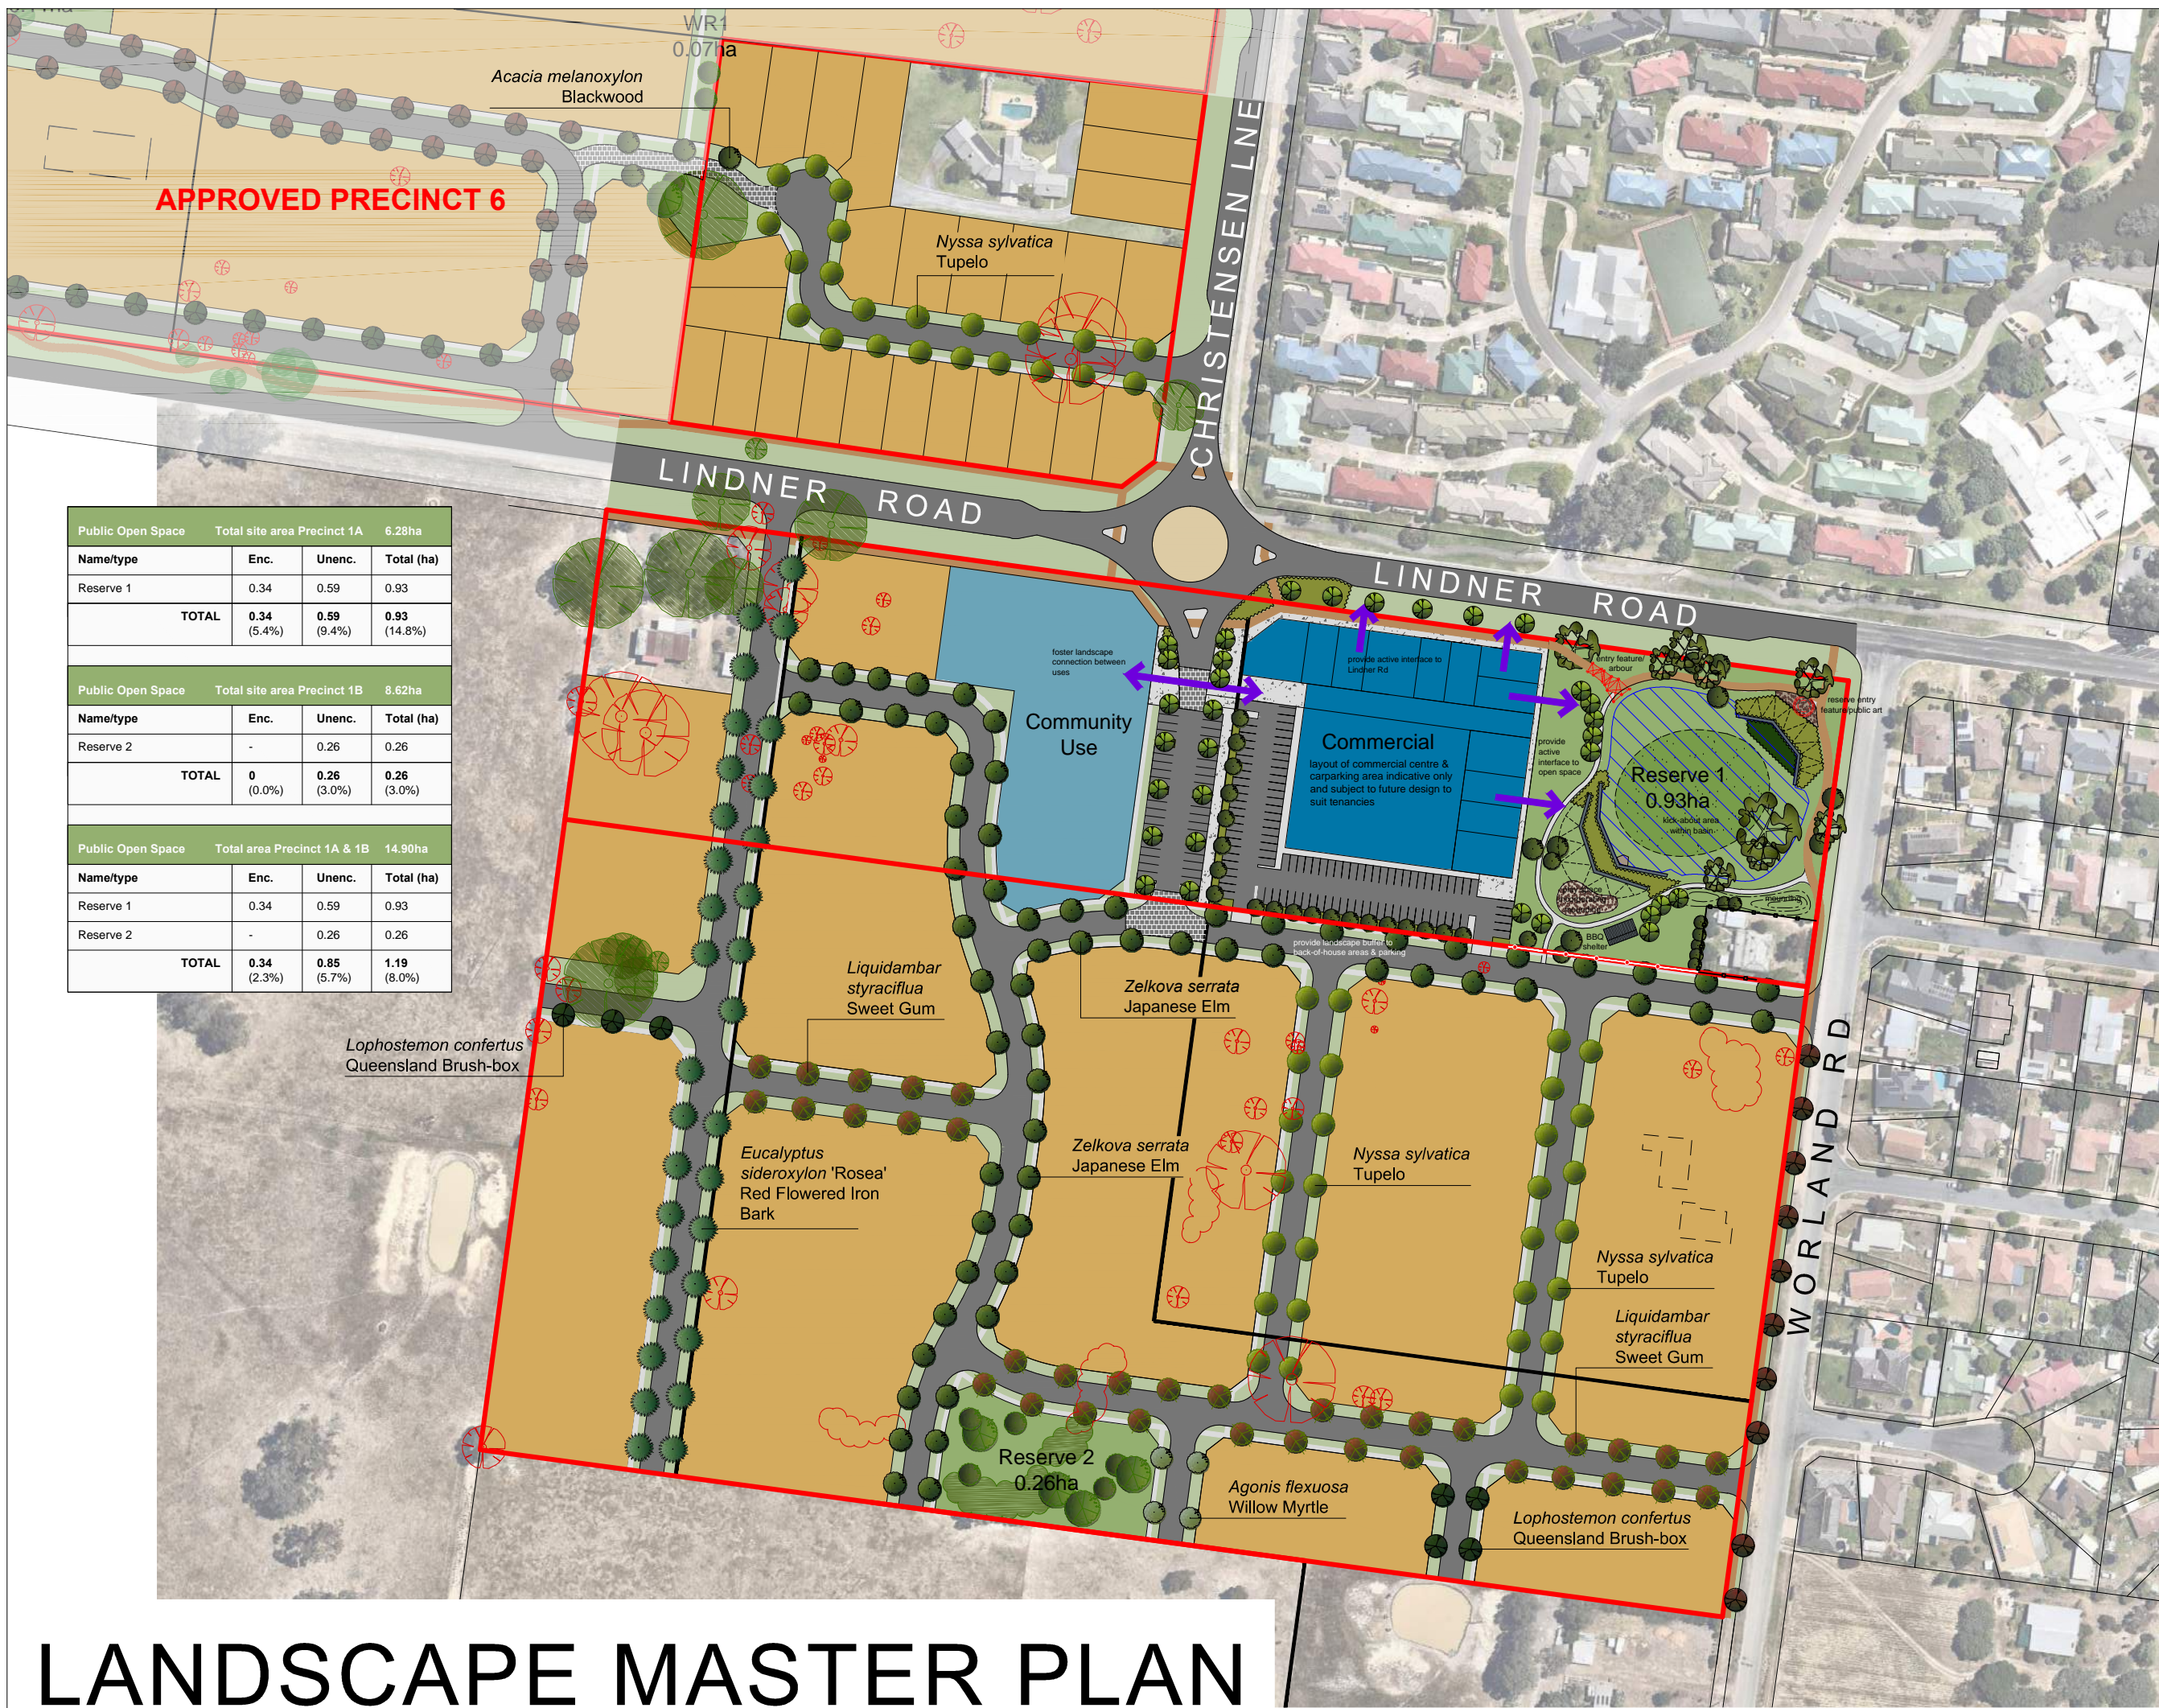
LANDSCAPE MASTER PLAN

- Legend**
- Proposed residential lots
 - Proposed shared path - 2.5m wide
 - Proposed footpath - 1.5m wide
 - Proposed street tree planting - refer to plans for suggested species
 - Proposed park planting
 - Grassed areas - naturestrips
 - Grassed areas - reserve
 - Garden bed areas - Shrubs, grasses & groundcovers at typically 4/m2
 - Fencing type 1 - Solid fencing 1.8m high.
 - Fencing type 3 - Open style fencing or bollards
 - Native vegetation to be retained
 - Native vegetation to be removed
 - Land encumbered by drainage function

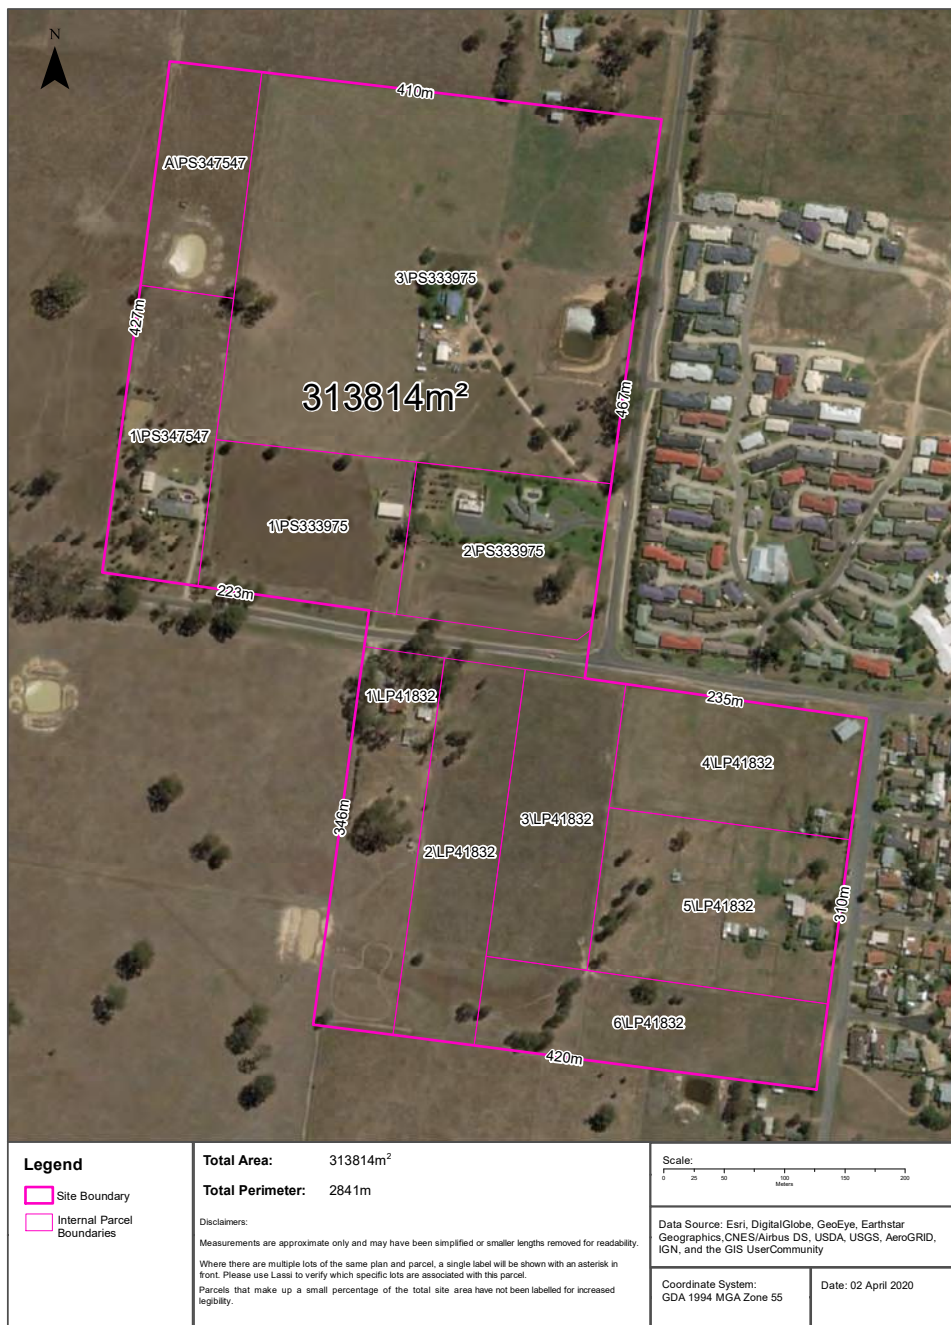
Figure 2-1: Aerial image and parcels (from Lotsearch report)

Figure 2-1 displays the site boundary, and internal parcel boundaries, overlaid on an aerial photo.

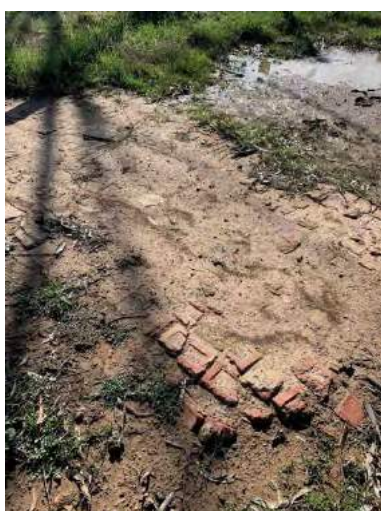
Figure 3-1: Bricks used to build up gateway area

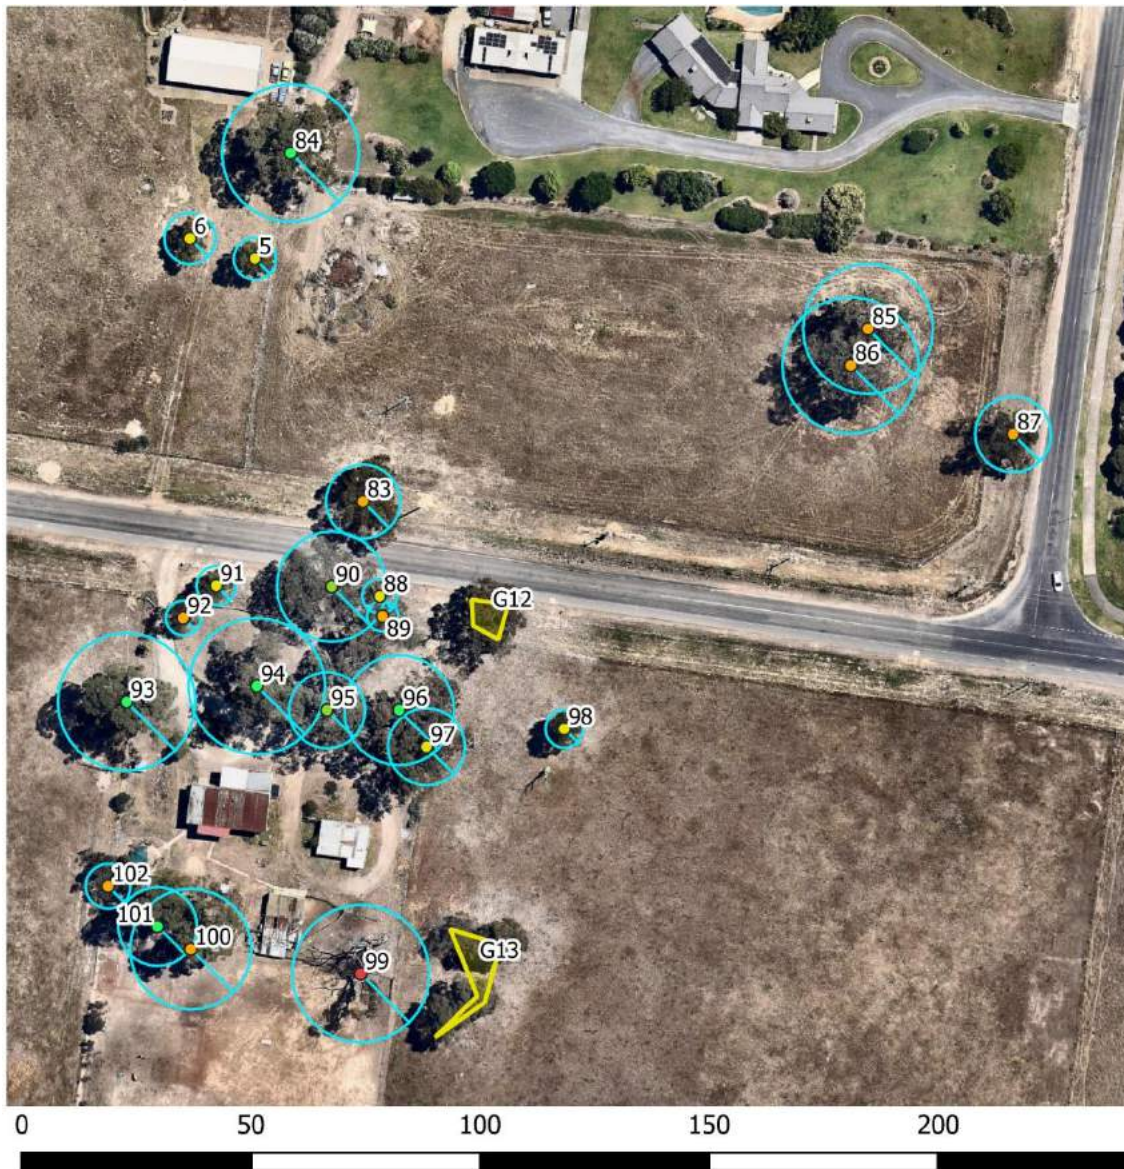
Map 1

Wangaratta north west growth area structure plan.
Precinct 1A

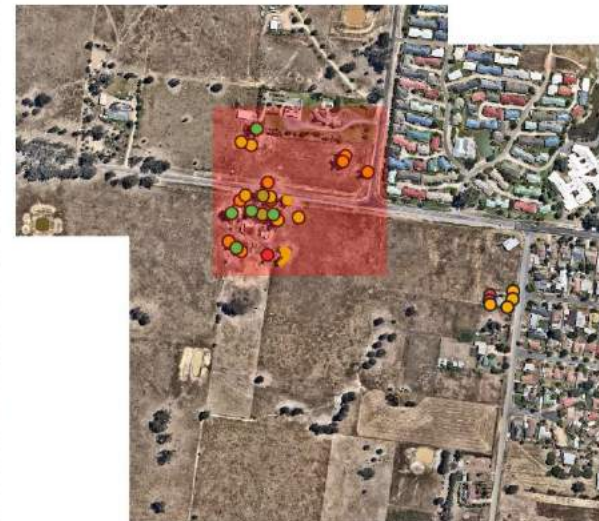
Map 2

Wangaratta north west growth area structure plan.
Precinct 1A

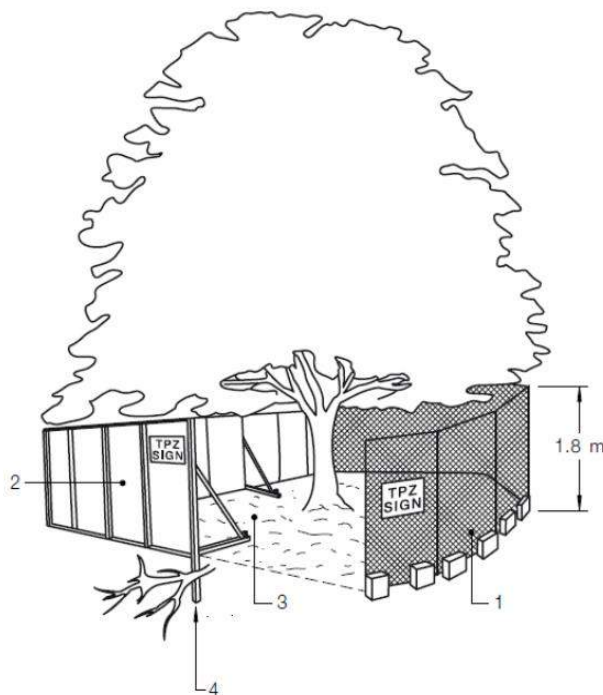
TREE PROTECTION ZONE SIGN EXAMPLE
(Informative)

TPZ sign provides clear and readily accessible information to indicate that a TPZ has been established. Figure C1 provides an example of a suitable sign.

Protective fencing is used to delineate the TPZ. The fence must provide high visibility and act as a physical barrier to construction vehicles. No construction activity is to be undertaken within the fenced TPZ. The fence should be adequately signed, be sturdy and prevent the entry of heavy equipment, vehicles, workers and the public.

Once erected, protective fencing must not be removed or altered without approval by the project arborist or responsible authority. The TPZ should be secured to restrict access. Tree protection fencing will consist of chain wire mesh panels held in place with concrete feet. The tree protection zone shall be clearly signed “Tree Protection Zone – No Access”.

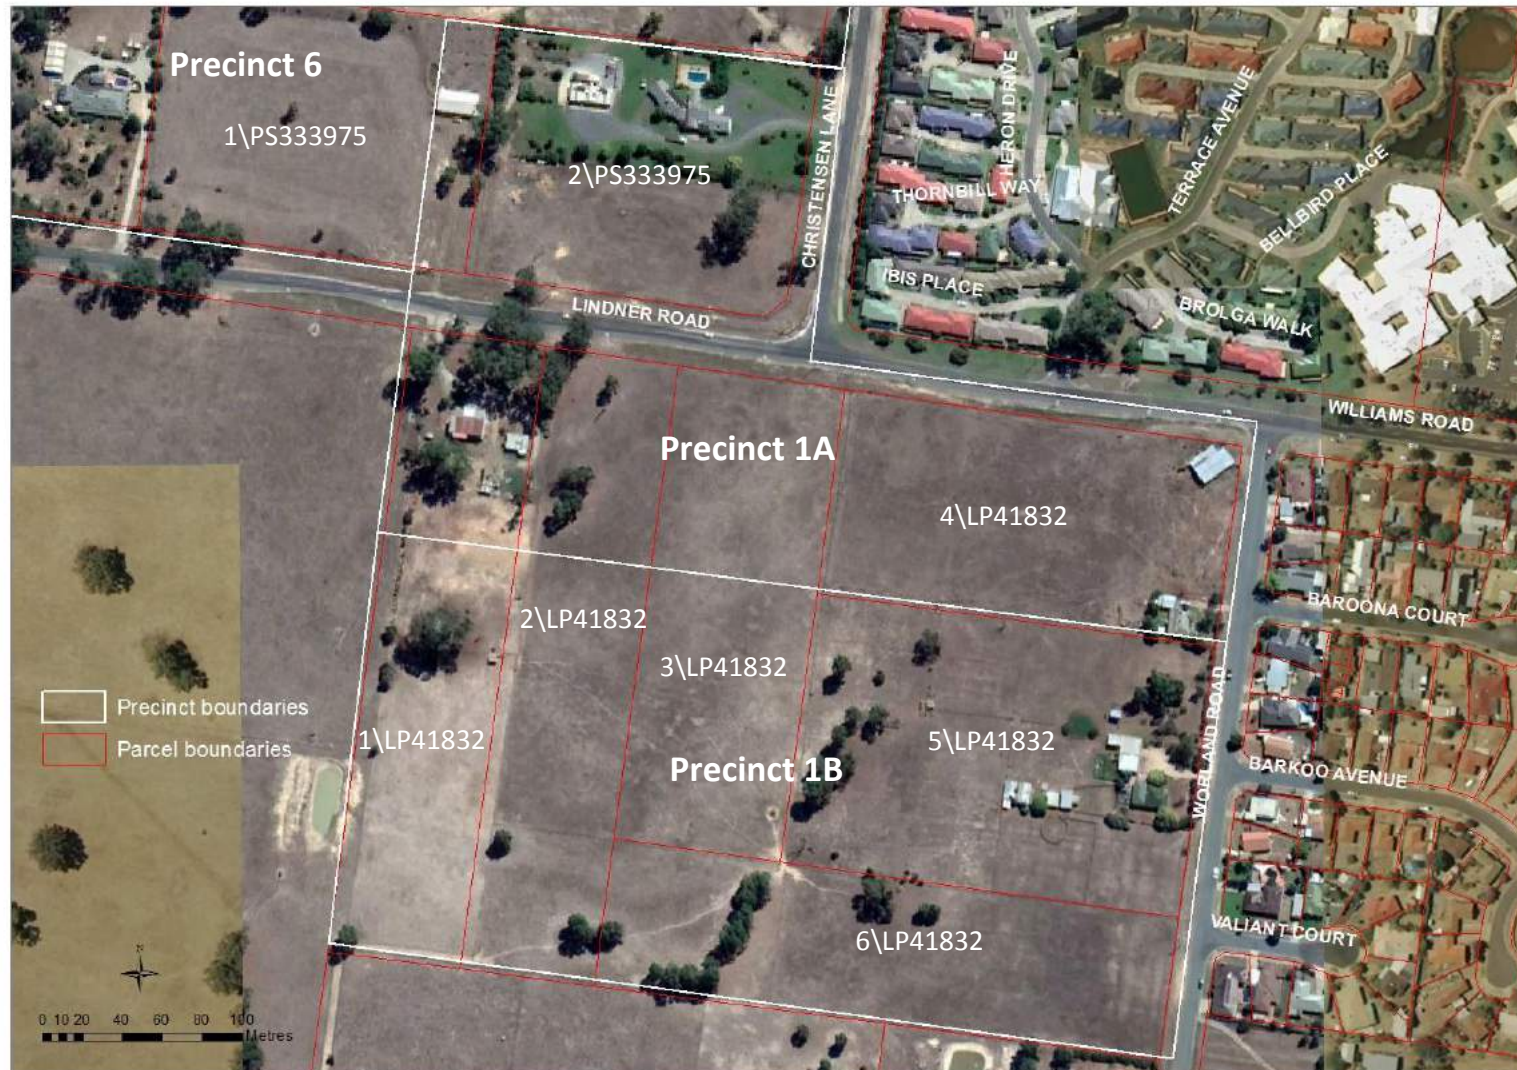
Figure 2-2 Aerial image of the Precincts showing parcel boundaries and identifiers in white (Image from Department of Sustainability and Environment [DSE] 2006, with an insert from Google Earth dated 14/2/2019).

Precinct 1A is an irregular shape, with maximum dimensions of 260 m north-south, and 430 m east-west, and has frontages on both Christensen Lane and Worland Road on its eastern boundary; the Precinct is bisected by Lindner Road with Lot 2 PS333975 on the corner of Christensen Lane and Lindner Road and the eastern section of Lot 1 PS333975 found north of Lindner Road (Fig. 2-2).

The Precincts comprise seven whole parcels (Lots 1 to 6 LP41832 and Lot 2 PS\333975), and the eastern section of Lot 1 PS\333975, all within the RCoW area (see Fig. 2-2).

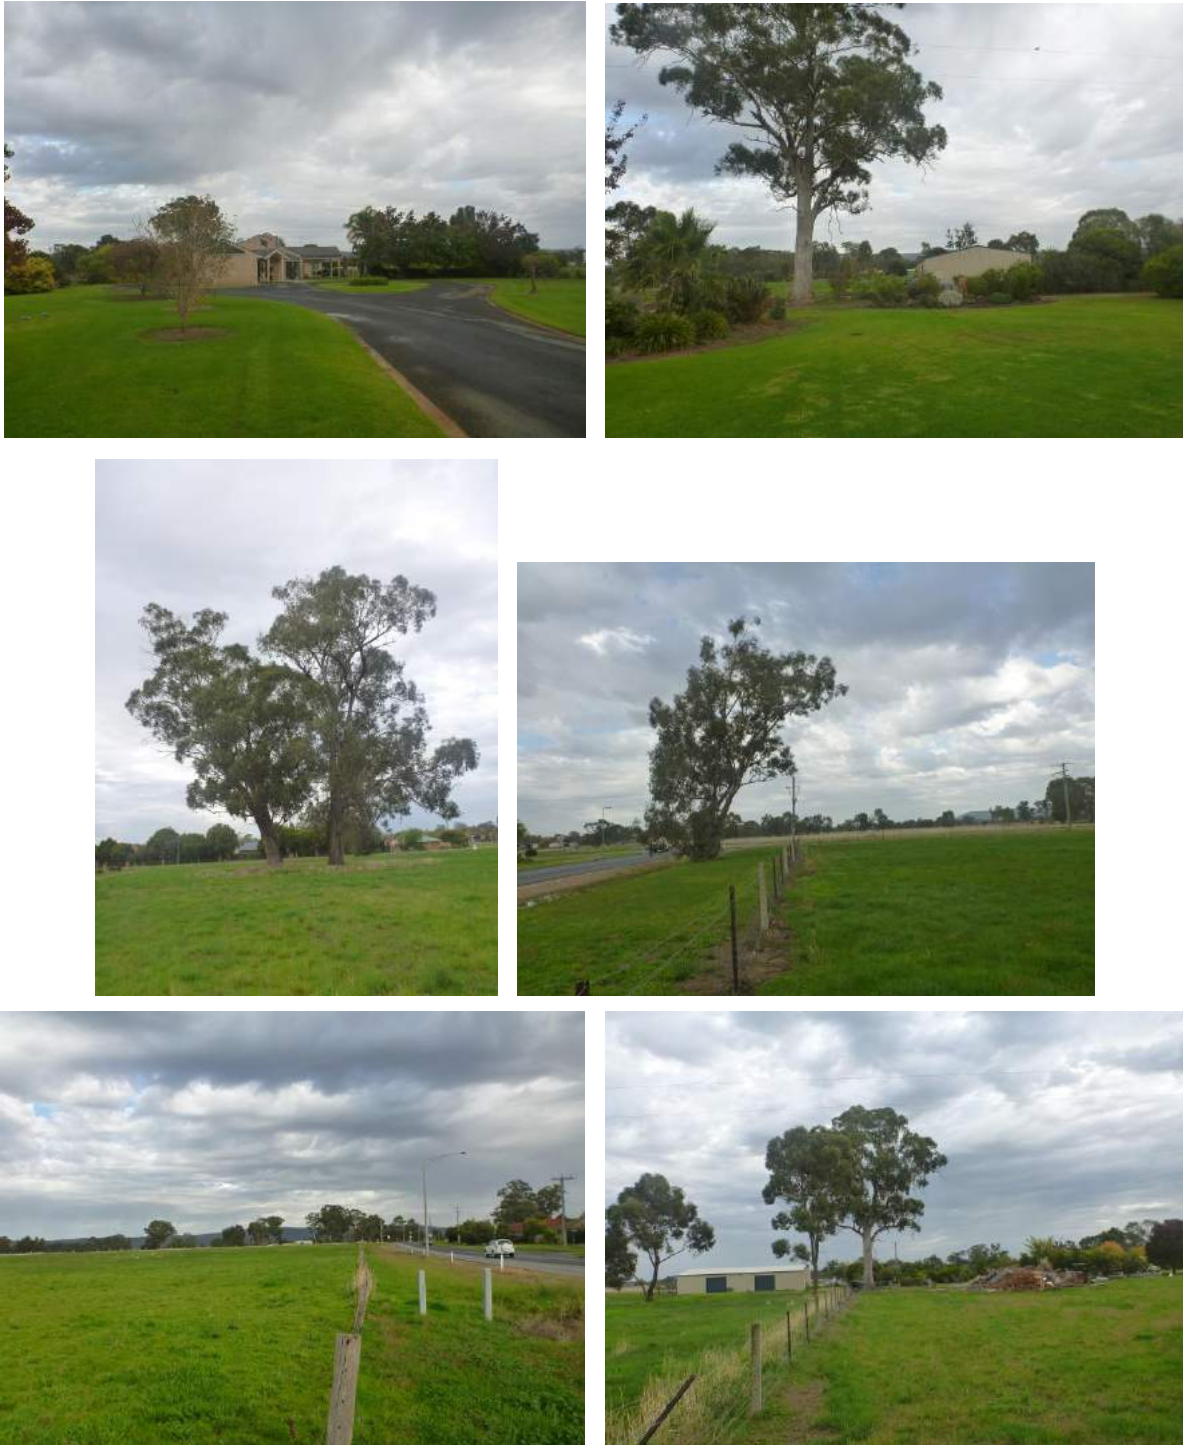
Plate 4-1 General views of Precinct 1A: the existing dwelling and garden at 11 Christensen Lane (top left), the western garden area at 11 Christensen Lane and Tree 1 (top right), Trees 2 and 3 at 11 Christensen Lane (middle left), Tree 17 on the Christensen Lane reserve (middle right), the Lindner Road reserve adjacent to 11 Christensen Lane (bottom left), and looking north from Lindner Road into the eastern section of Lot 1 PS339975 (bottom right).

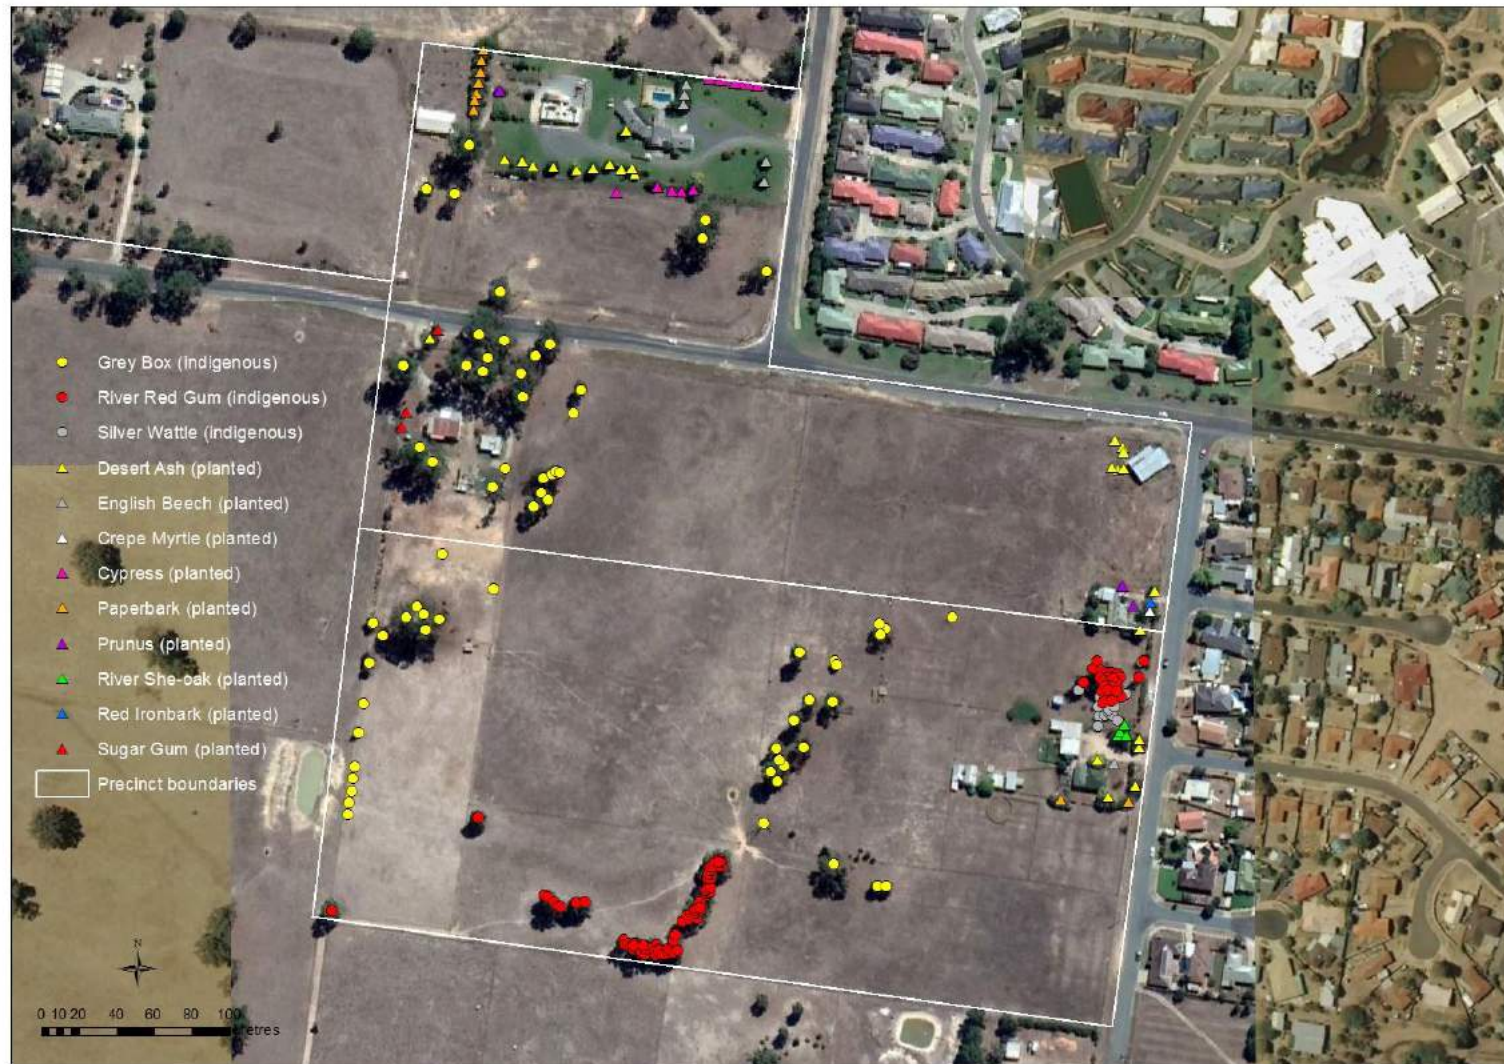
Figure 4-1 Aerial image showing the location of assessed trees across the assessed Precincts. Assessed trees and shrubs are shown as dots. Image from DSE (2006), with an insert from Google Earth dated 14/2/2019.

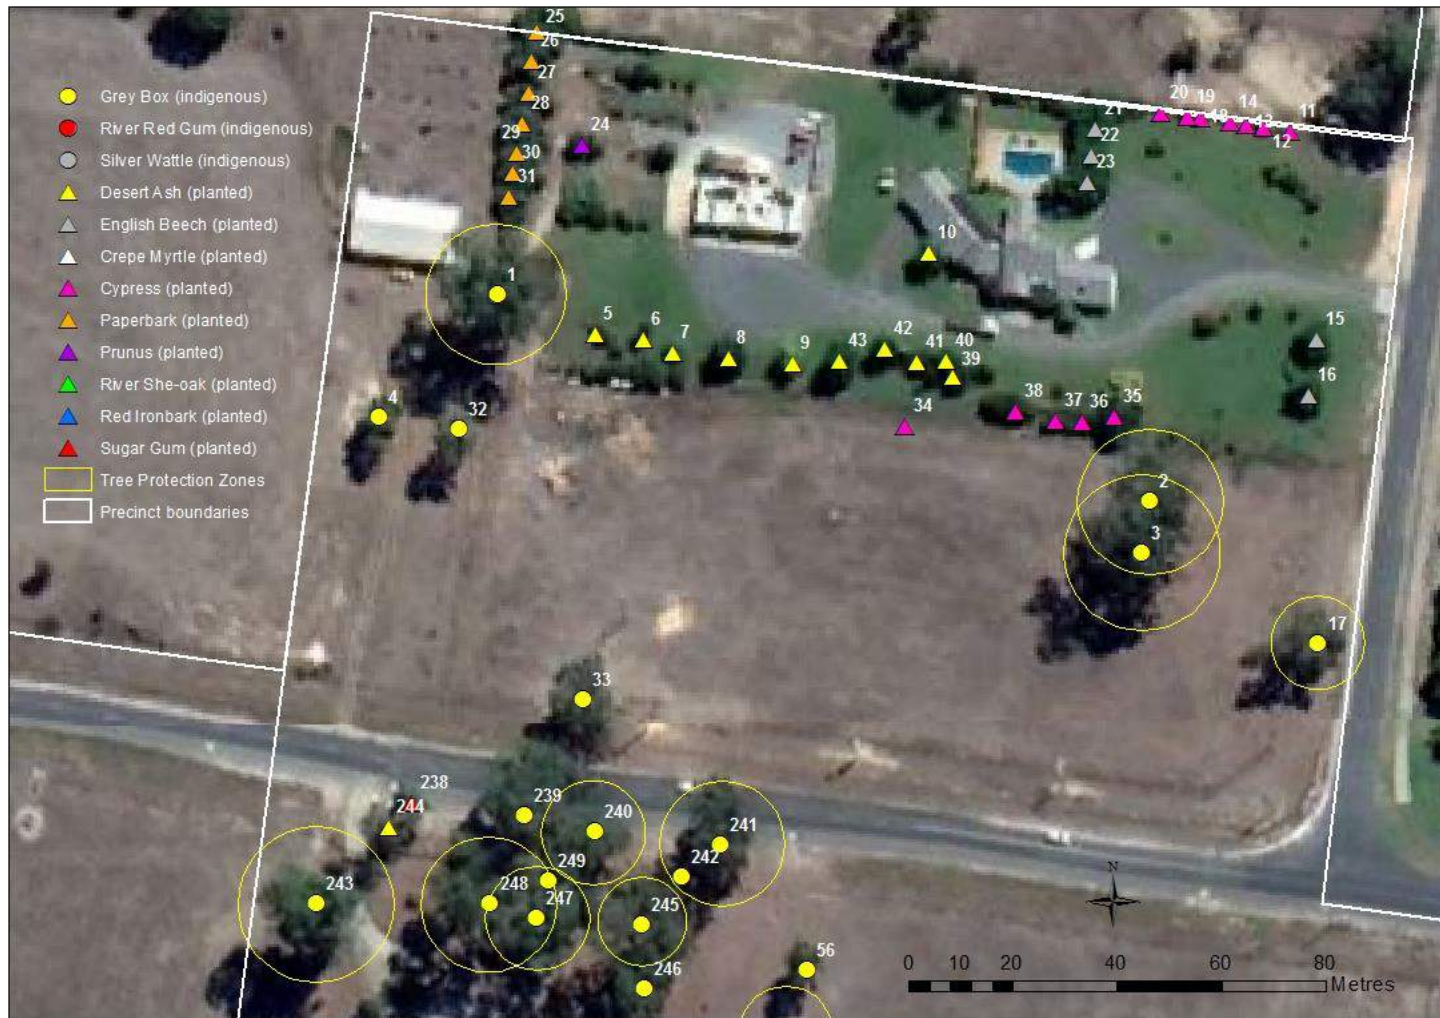
Figure 4-2 Aerial image showing the location of assessed trees and shrubs across the northern section of Precinct 1A. Assessed trees are shown as symbols and numbered; numbers refer to the table of tree characteristics in Appendix D. Large Trees (indigenous trees) also have a Tree Protection Zone drawn around them. Image from Google Earth dated 14/2/2019.
